## PARTS BREAKDOWN

| DATE | CHKD | 1117LN

PART NUMBER
0580000675
REVISION
2

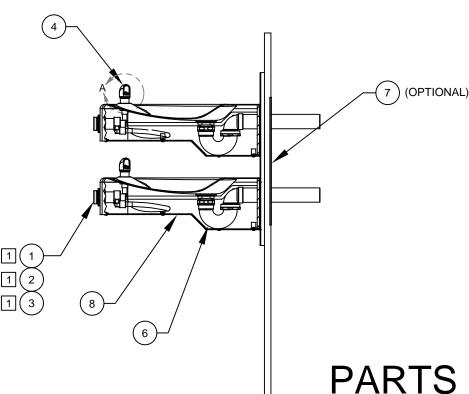
1 5874PBF (ITEM 2) INCLUDES VRK5874 CARTRIDGE ASSEMBLY (ITEM 3) AND PBA6 FLANGED PUSH BUTTON (ITEM 4).

2 ENSURE TUBE IS DISCONNECTED FROM PUSH BUTTON VALVE BODY PRIOR TO REMOVAL. APPLY ONE DROP OF LOCTITE 222MS TO NOZZLE THREADS PRIOR TO FASTENING BACK ONTO BUBBLER HEAD. RE-ATTACH TUBE TO VALVE.

ITEM	DESCRIPTION	1117LN
	1	BUTTON, PUSH, FLANGED, PCP W/ VALVE	5874PBF
	2	VALVE REPAIR KIT	VRK5874
	3	PUSH BUTTON ASSY	PBA6
	4	BUBBLER HEAD ASSY, PCP	5703M
	5	STRAINER, WASTE ASSY	6462
	6	TRAP	0005982900
(OPTIONAL)	7	PLATE MOUNTING	6700.4
	8	PLATE BOTTOM	PBM1107
