model PBA6

Valve Button

INSTALLATION INSTRUCTIONS FOR 5874PBF.

INSTALLATION INSTRUCTIONS FOR 5874PB.

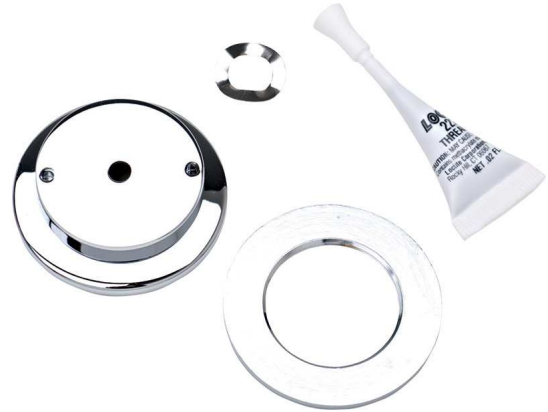
Model PBA6 flanged push button assembly is used with push button valve 5874, is made of polished chrome-plated brass, and includes the push button with front adjusting screw, operator, round locknut, snap ring, and wave washer. This model is used on flush mounted (not recessed) front stainless steel drinking fountain models.
