PARTS BREAKDOWN

Haws [®]		1455 KLEPPE LANE SPARKS, NEVADA 89431 (775) 359-4712 FAX (775) 359-7424 E-MAIL: HAWS@HAWS.CO.COM WEBSITE: WWW.HAWS.CO.COM	
				ECN NO. REVISED PER BY ECN: 5527 FV	MODEL(S) 1117L
DRAWN C.FENNER	DATE 10/28/06	CHKD DP			
APPROVED FV	DATE 04/02/20	SCALE: 1:1	DRAWING TYPE: PARTS BREAKDOWN	SIZE: A	SHEET 1 OF 1

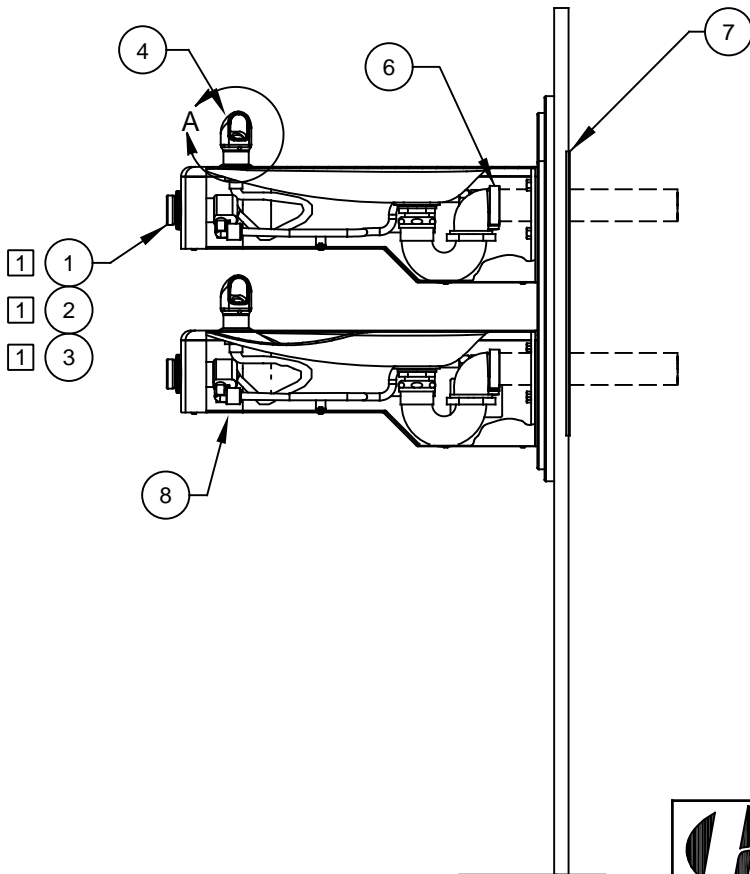
ITEM	DESCRIPTION	PART #
1	BUTTON, PUSH, FLANGED, PCP W/ VALVE	5874PBF
2	VALVE REPAIR KIT	VRK5874
3	PUSH BUTTON ASSY	PBA6
4	BUBBLER HEAD ASSY, PCP	5703M
5	STRAINER, WASTE ASSY	6462
6	TRAP	0005982900
** 7	MOUNTING PLATE	6717
8	BOTTOM PLATE	PBM1107

- 1 5874PBF (ITEM 2) INCLUDES VRK5874 CARTRIDGE ASSEMBLY (ITEM 3) AND PBA6 FLANGED PUSH BUTTON (ITEM 4).
- 2 ENSURE TUBE IS DISCONNECTED FROM PUSH BUTTON VALVE BODY PRIOR TO REMOVAL. APPLY ONE DROP OF LOCTITE 222MS TO NOZZLE THREADS PRIOR TO FASTENING BACK ONTO BUBBLER HEAD. RE-ATTACH TUBE TO VALVE.
