# PARTS BREAKDOWN

<b>Haws</b> <sup>®</sup>		1455 KLEPPE LANE SPARKS, NEVADA 89431 (775) 359-4712 FAX (775) 359-7424 E-MAIL: HAWS@HAWSCO.COM WEBSITE: WWW.HAWSCO.COM	
				ECN NO. REVISED PER BY ECN: 5530 FV	MODEL(S) 1119.14
DRAWN f. DATE 06/06/98 CHKD DP	APPROVED NE DATE 03/26/20	SCALE: 1:1	DRAWING TYPE: PARTS BREAKDOWN	SIZE: A	SHEET 1 OF 1

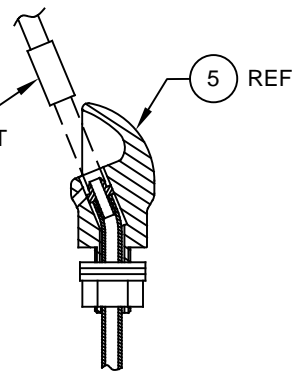
2 REMOVE INSERT WITH 5/16 HEX SOCKET (NOT SUPPLIED)

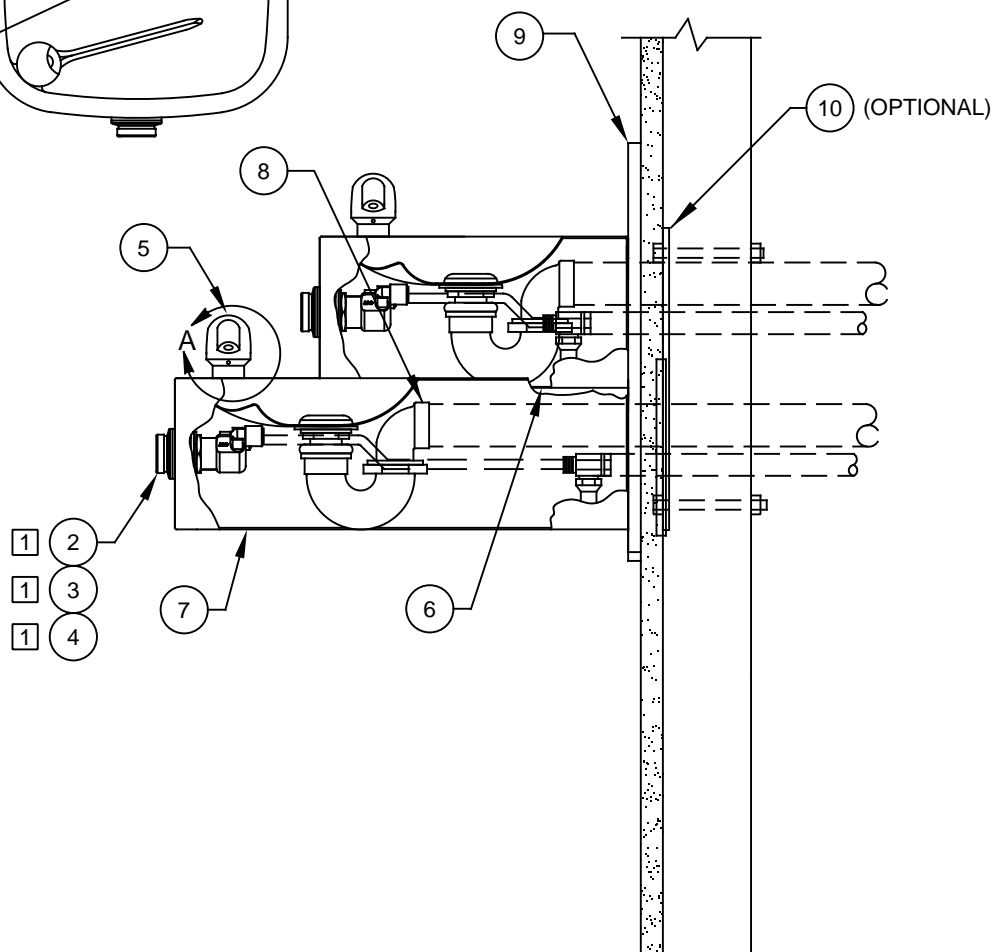
ITEM	DESCRIPTION	1119.14
1	STRAINER, WASTE ASSY	6462
2	BUTTON, PUSH, FLANGED, PCP W/ VALVE	5874PBF
3	VALVE REPAIR KIT	VRK5874
4	PUSH BUTTON ASSY, FLANGED, PCP	PBA6
5	BUBBLER HEAD ASSY, PCP	5703M
6	PLATE, BOTTOM	PBM1105
7	PLATE, BOTTOM	PBM1109
8	TRAP	0005982900
9	BACK PANEL	0004023580
* 10	PLATE, MOUNTING	6700.4

- 1 5874PBF (ITEM 2) INCLUDES VRK5874 CARTRIDGE ASSEMBLY (ITEM 3) AND PBA6 FLANGED PUSH BUTTON (ITEM 4).
- 2 ENSURE TUBE IS DISCONNECTED FROM PUSH BUTTON VALVE BODY PRIOR TO REMOVAL. APPLY ONE DROP OF LOCTITE 222MS TO NOZZLE THREADS PRIOR TO FASTENING BACK ONTO BUBBLER HEAD. RE-ATTACH TUBE TO VALVE.
