PARTS BREAKDOWN

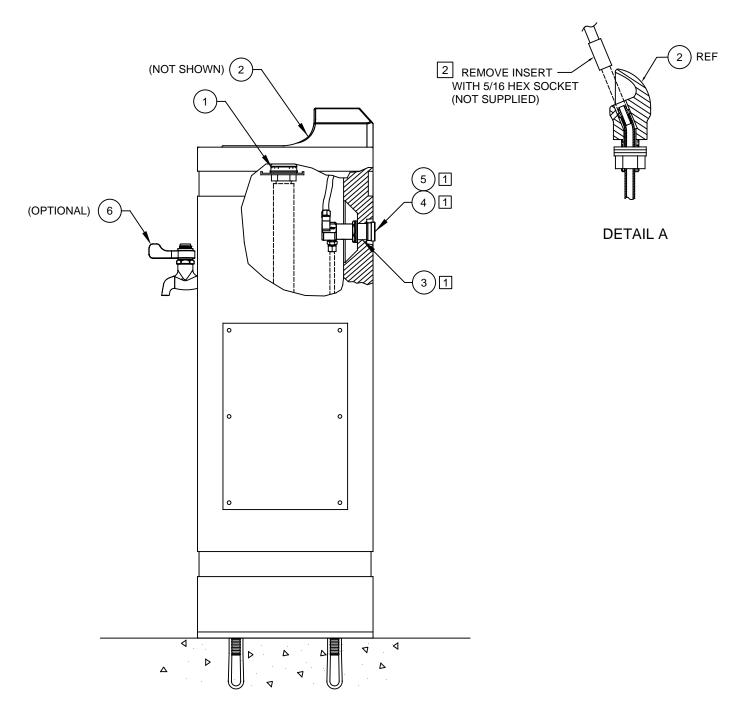
- 1 5874PB (ITEM 3) INCLUDES VRK5874 CARTRIDGE ASSEMBLY (ITEM 4) AND PBA7 FLANGED PUSH BUTTON (ITEM 5).
- 2 ENSURE TUBE IS DISCONNECTED FROM PUSH BUTTON VALVE BODY PRIOR TO REMOVAL. APPLY ONE DROP OF LOCTITE 222MS TO NOZZLE THREADS PRIOR TO FASTENING BACK ONTO BUBBLER HEAD. RE-ATTACH TUBE TO VALVE.

3 USE MODEL 6250LF WITH ACCESS PLATE, PN 0004499489.

ITEM	DESCRIPTION	PART NO.
	1	STRAINER WASTE ASSY, PCP	6466
	2	BUBBLER HEAD ASSY, PCP	5703M
	3	BUTTON, PUSH, NON-FLANGED, PCP	5874PB
	4	VALVE REPAIR KIT	VRK5874
	5	PUSH BUTTON ASSY	PBA7
*	6	VALVE, BIB FAUCET, PCP	6250LF
